## An Archaeological Curation-Needs Assessment for the U.S. Navy, Atlantic Division, Naval Facilities Engineering Command

Archaeological Curation-Needs Assessment Technical Report No. 14

# An Archaeological Curation-Needs Assessment for the U.S. Navy, Atlantic Division, Naval Facilities Engineering Command

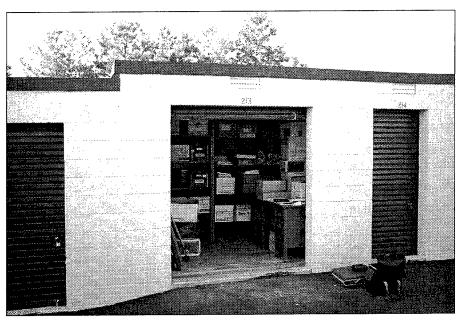
Figure 1. Exterior of the ARC storage location.

Archaeological collections from completed, inactive projects are housed at a storage location separate from the firm's offices. This temporary repository is one unit in a commercial storage facility, Colonial Self-Storage, which is also located in Raleigh (Figure 1). ARC's storage unit encompasses approximately 100 ft<sup>2</sup>, in which space is allocated for artifacts, documentation, and field equipment.

The storage unit rented by ARC is one in a series of adjacent single-story units. Each unit in the complex has a concrete foundation, concrete-block exterior walls, and plasterboard interior walls. The roof is corrugated metal, and the storage area has no windows. The only utility present is electricity. There have been no renovations, but the facility is structurally sound. There is one exterior, overhead loading door, which faces north. The space is used strictly as artifact, documentation, and field-equipment storage space, with metal storage units. It is filled to approximately 60-percent capacity.

There are no temperature, humidity, or dustprevention environmental controls. Lighting is provided by nonultraviolet-filtered incandescent bulbs. Maintenance of the rented space is performed by ARC.

- 6. Ensure that there are adequate environmental controls. Install an HVAC system if possible. If this is not feasible, ensure temperature regulation through the use of central air-conditioning and heating. Monitor humidity with a sling psychrometer or hygrothermograph and install a dehumidifier.

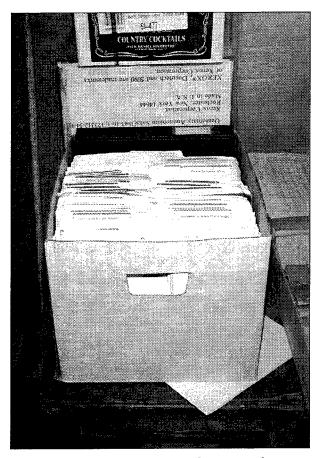
Secondary containers for the documentation associated with MCAS Cherry Point in Container 1 include acidic-paper folders and bound material (see Figure 3); loose materials are also present. Acidic-paper folders are labeled with typed, adhesive, paper tags; information includes the contents of the folder. Bound material is la-

Figure 3. Documentation stored in acidic folders within an acidic-cardboard box at the ARC storage location.

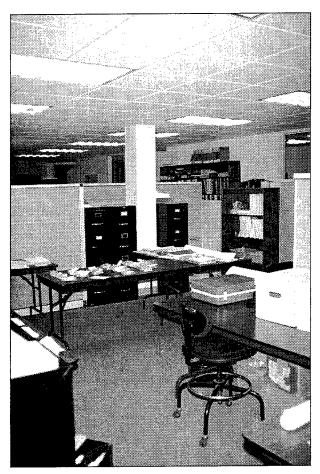
The offices of EHA encompass approximately 9,000 ft² of the 60,000 ft² building. Within this area there are offices, a mechanical and utility room, and a laboratory and collections storage area. The collections storage area totals approximately 280 ft², is defined by walls, and is divided into subareas (Figure 4). These subareas include an artifact-holding area, a processing lab, a temporary artifact-storage area, and a records-storage area. The suspended, acoustical ceiling of the office has recessed

Figure 4. Standard office partitions delineate the collections storage area at EHA.

fluorescent lights. There are no windows in direct proximity to the collections storage area; they are all located within walled offices surrounding the center of the office space leased by the firm. If Atlantic Navy collections are to be kept at EHA, some rehabilitation of the collections storage area is necessary.

- 2. Move documentation to an interior room where the environment can be controlled and the materials can be secured. Install an HVAC system. If an HVAC system is infeasible, monitor humidity with a sling psychrometer or hygrothermograph and install a dehumidifier. Secure the documentation by installing key and dead bolt locks and a security system for the room.

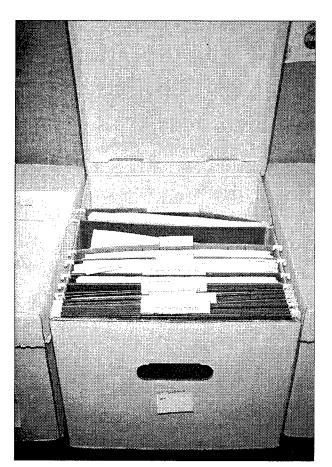
Figure 5. Documentation is stored in acidic hanging file folders within acid-free boxes.

This is not an archival procedure.

sleeves and laid loose in the box with original reports. The photographs are not labeled.

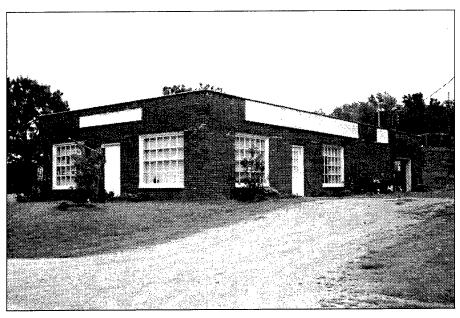
This single-story building, approximately 20–25 years old and originally used as a restaurant, was at some point converted to offices (Figure 6). JRIA is currently renting this building, which they moved into approximately two years

The structure's foundation and walls are sound. The roof occasionally leaks over the laboratory area, but not over the collections. There are five windows in the building, all of which have wooden frames, and all but one are equipped with shades. Two of the windows face north, two face west, and one faces south. The south-facing window, which is located in the collections storage area, is not equipped with a shade. Utilities present consist of water, electricity, and telephone, all probably original to the building.

Figure 6. Exterior view of JRIA.

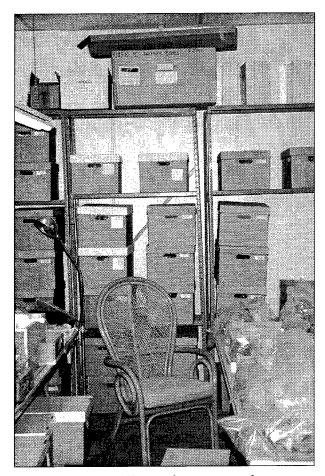
Figure 7. Artifact primary containers are stored two or three high on metal shelves, causing compression.

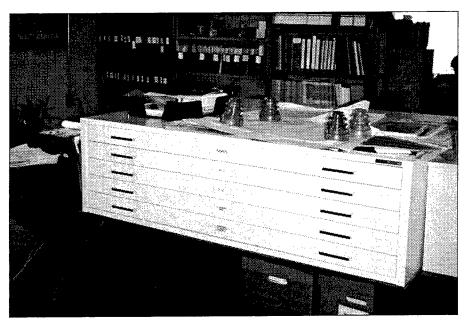
There are 1.5 linear inches of maps (see Table 9), which are stored in two places: a map case (Figure 9) and the acidic, expandable files containing the paper records. The map case is an enameled-metal, five-drawer cabinet with matboard dividers. Large-scale maps are stored in the map case and are arranged alphabetically, by naval facility. Small-scale maps are folded and stored in the acidic, expandable files with the paper records.

Figure 9. Large maps are properly stored in an archival-quality, metal map flat.

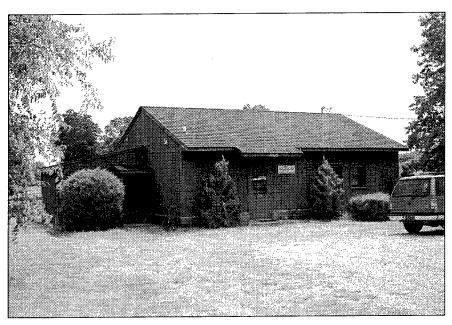
The building, which originally served as offices, is approximately 10 years old. The firm's single-floor building has a concrete foundation and wooden siding, with plasterboard interior walls. The asphalt-shingled roof is original to the building, which appears to be structurally solid. There are six wood-framed windows in the building, all equipped with blinds. Three of the windows face west, two face east, and one faces south; no cracks or signs of leakage were observed during

Figure 10. Exterior view of MAAR.

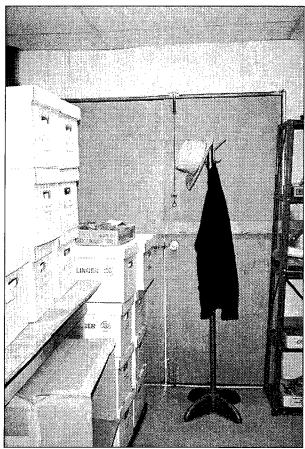
Figure 11. Exterior doors in the collections storage area. Environment and security are compromised by the gap between the doors.

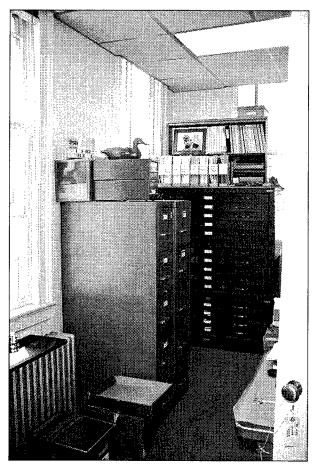
Figure 14. The records storage room at NCOSA. Documentation is stored in file cabinets in proximity to exterior windows.

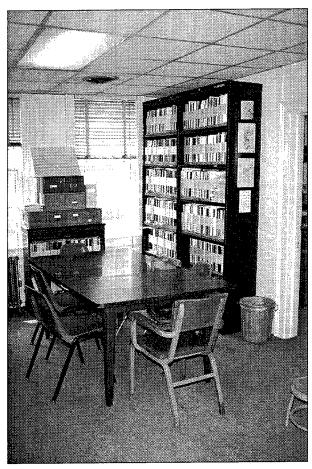
Figure 15. The reports library. Reports are stored in acidic magazine holders on wooden and metal shelves.

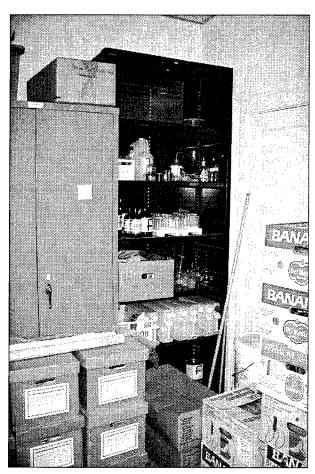
Figure 16. Hazardous chemicals are stored in proximity to archaeological collections in Collections Storage Area 1.

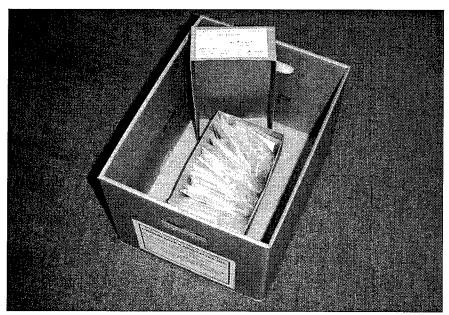
Figure 17. Only some artifacts are stored in acid-free, archival-quality primary and secondary containers.

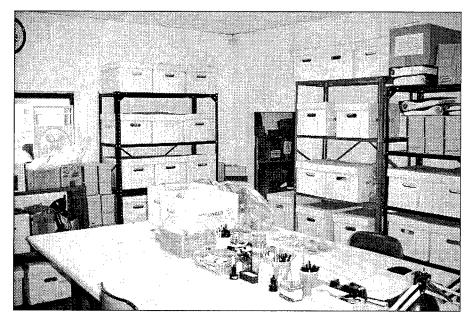
Figure 19. Collections storage units at Goodwin are enameled-metal shelves.

Archaeological and associated documentation collections are stored on standard, enameled-metal shelving units measuring approximately  $3.0 \times 5.8 \times 1.3$  feet (w × h × d) (see Figure 19). Each unit is five shelves high, and boxes are stacked one to two high.

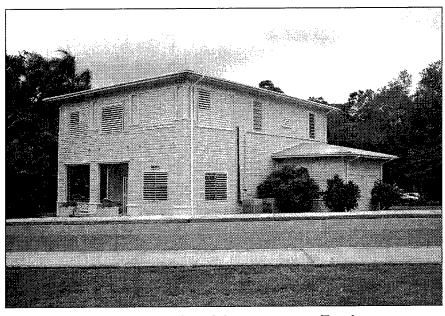
The collections storage area is currently filled to approximately 95-percent capacity. This area exhibits flaws; evidence of severe termite infestation is present around the windows, and the lack of panes in the windows poses a security risk. If Turabo is to continue to be used for the long-term curation of federal archaeological

Figure 21. Exterior of the museum at Turabo.

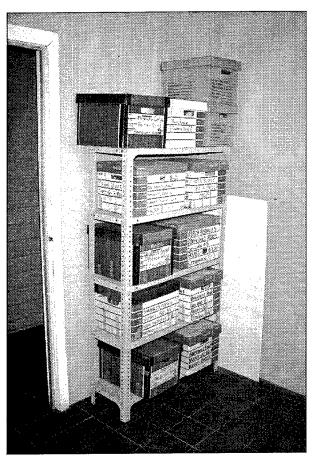
Figure 23. View of storage unit and nonarchival primary containers housing Atlantic Navy collections.

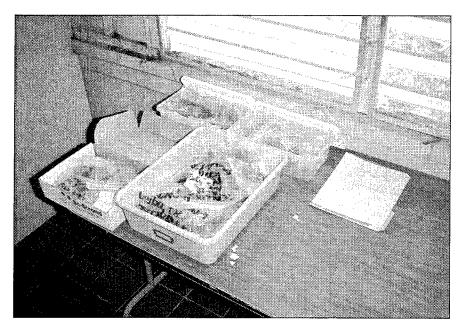
Figure 25. Primary containers housing diagnostic artifacts.

All artifacts from NAVSTA Roosevelt Roads have been cleaned and sorted by material class, but only 15 percent have been labeled. The labeled artifacts, those considered diagnostic, are stored in the plastic tubs (see Figure 25). These have been directly labeled with india ink over a base of white correction fluid; label information includes site number, provenience, and artifact number.

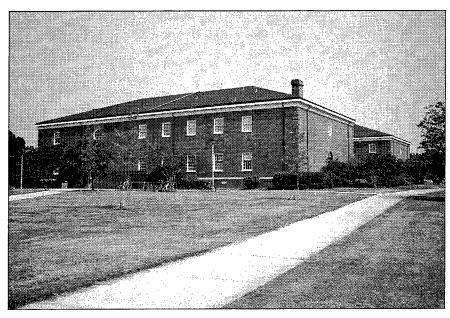
The social and behavioral sciences building was constructed in 1981 to function as a classroom, laboratory, and office space. It has a concrete foundation, a shingled roof, and brick exterior walls. The interior walls are constructed of concrete blocks and plasterboard. The floor in the artifact and records storage area (Room 100B) consists of poured-and-sealed concrete, whereas that in the rest of the building is concrete overlain with tile. Although there are multiple windows in the building, none is present in the collections storage areas. The St. Louis District team entered the building through the loading dock by means of an exterior, double, metalpanel door. Within the repository, there is a double, wood-panel door in the south wall of the artifact and records storage area (Room 100B), whereas single-panel, wooden doors allow access to the slide and photograph storage areas (Rooms 100C and 100E, respectively). Plumbing, heating, and electrical systems are original to the building. Construction of interior walls for additional rooms and hallways constitute the

Figure 26. Exterior view of the UNCW repository.

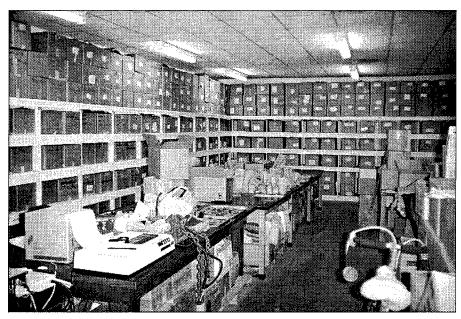
Figure 27. The filled-to-capacity Collections Storage Area 1 (Room 100B) at UNCW.

Note artifact containers stacked two and three high.

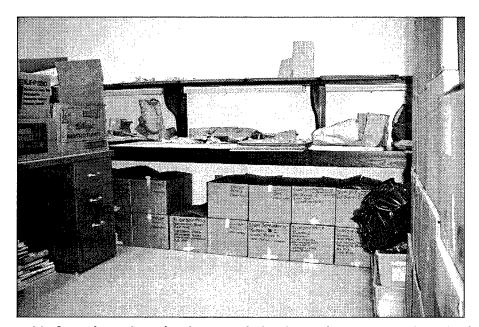
Figure 28. Containers housing human skeletal remains are stored on the floor in Collections Storage Area 2 at UNCW.

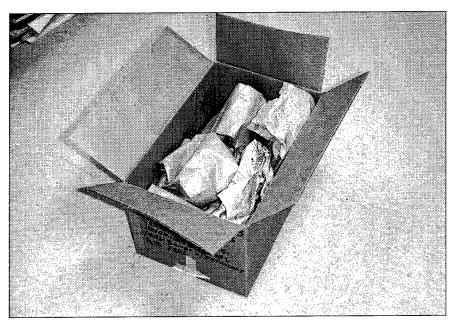
Figure 29. A variety of unsuitable secondary containers house human skeletal remains at UNCW.

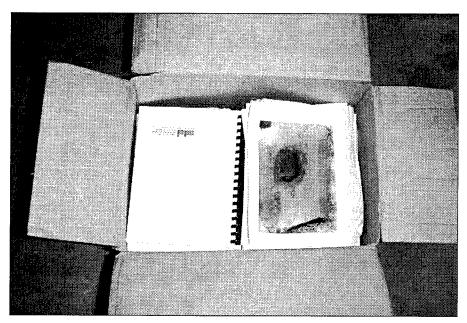
Figure 30. Photographs and reports stored loose in the same acidic container is not archival storage practice.

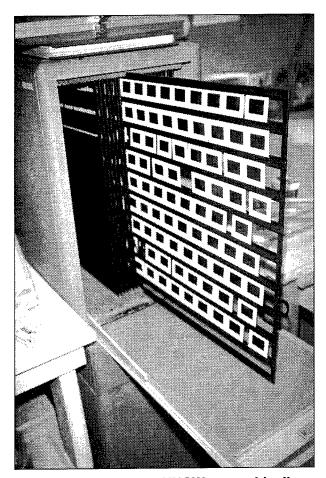
The 10.5 linear inches of color slides present in this collections storage area are stored in a locked, metal slide cabinet measuring  $1.3 \times 2 \times 2$  feet (w × h × d; Figure 31). All slides are directly labeled with file number in pen or marker. A finding aid is available that details field number, file number, subject, date, and direction of view.

Figure 31. Slides at UNCW are archivally stored in hard plastic sleeves within a metal cabinet.

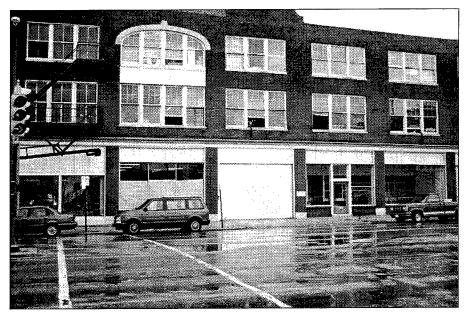
have been extensive interior renovations in the office sections of the building, including the addition of central heating and air-conditioning. Plumbing, electrical, and environmental utilities were upgraded throughout the repository, but it is not clear when this occurred. The repository has multiple windows on its southwest and northeast sides. One exterior door is present in the rear (southwest) of the repository, and one exterior, wood-framed, glass door and an overhead, metal garage door are present at the front (northeast) of the repository.

Figure 32. VCUARC occupies space behind the first-floor garage door and the two glassed-in areas toward the right of the photograph.

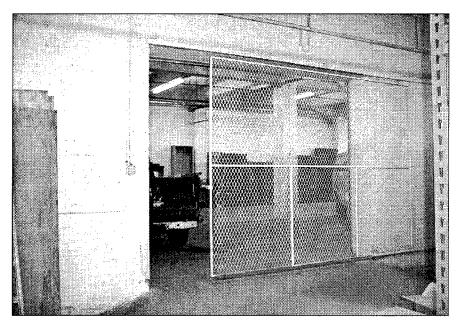
The offices section of the repository is separated from the garage and the collections storage area by an interior, southeast-facing, metalpanel door. The collections storage area is secured from the rest of the repository by a northwest-facing, rolling, metal-mesh gate that extends from the floor to the ceiling (Figure 33). There are eight windows in the collections storage area, all overlooking the rear (southwest) of the repository, and one exterior, metal-panel door that also faces southwest. Two of the windows have wooden frames and six of the windows have metal frames. Metal-mesh grating is present on the exteriors of all windows. The windows are not equipped with shades, but approximately 75 percent of them are opaque (Figure 34). The ceiling in the collections storage

Figure 33. Sliding, metal-mesh grate at VCUARC separates the collections storage area from the remainder of the repository.

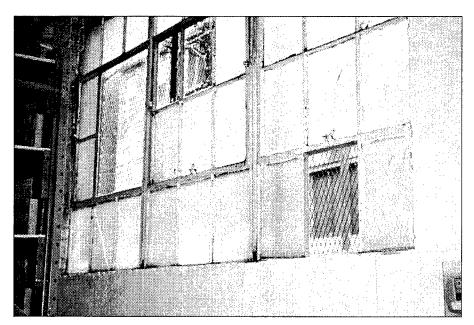
Figure 34. Exterior windows in the collections storage area; some panes are missing, and others are cracked. Note the metal-mesh grate on the exterior.

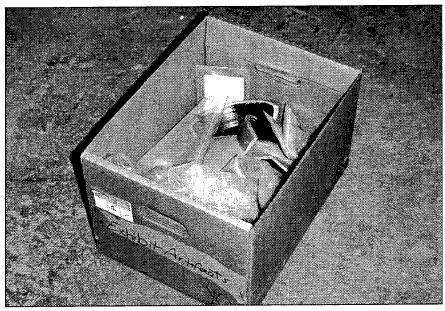
Figure 37. Secondary containers are predominantly nonarchival, zip-lock bags.

Note artifacts loose in the box.

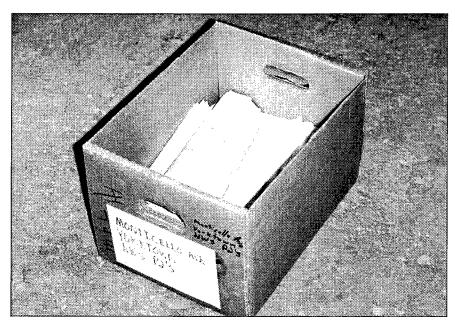
Figure 38. Documentation is stored loose or in acidic folders within an acidic-cardboard box.

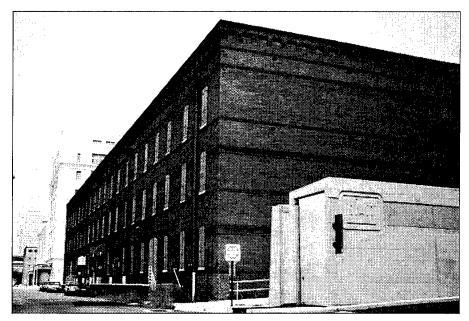
This building is structurally sound and certainly has ample floor space to serve as a collections storage location. However, several rehabilitation measures should be taken if it is to remain a long-term-curation repository.

Figure 39. Exterior view of the Extra Attic storage location, VDHR.

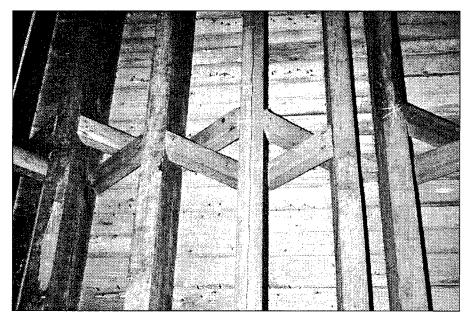
Figure 40. Close-up view of the ceiling supports in the Extra Attic storage location.

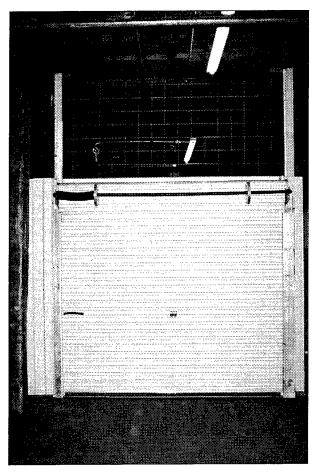
Figure 41. Metal mesh extends from the top of an overhead door to the ceiling, compromising security within the artifact collections area.

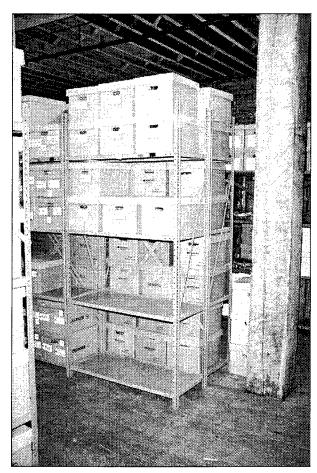
Artifact storage units present in this repository are open, enameled-metal shelving units that measure  $3.5 \times 7 \times 1.5$  feet (w × h × d) (Figure 42). Shelving units are numbered consecutively with adhesive tags that are attached to the top shelf of each unit. Artifact boxes are stacked two high on the shelves (see Figure 42).

Figure 42. Artifact primary containers are stacked two high on enameled-metal shelving units at the Extra Attic storage location.

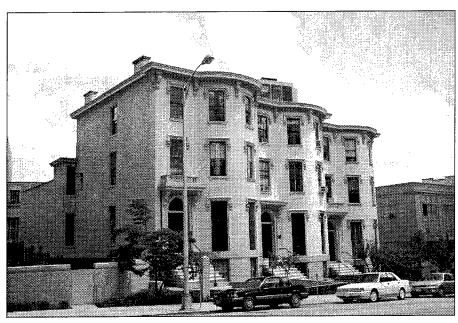
Figure 43. Exterior view of the Morrison Row storage location, VDHR.

involved in politics and the government (Figure 43). The records storage area containing documentation associated with Atlantic Navy projects is located in the basement of one of these former townhouses. There are three floors aboveground, and one below. Internal renovations took place four years ago, when ceilings were lowered, several new walls were added, an elevator was installed, and the plumbing and electrical systems were upgraded. The foundation is brick, the floor in the records storage area is concrete covered with carpet, and the roof is composed of built-up asphalt that has been replaced on an as-needed basis. There is a suspended, acoustical ceiling in the records storage area. Exterior walls are constructed of brick covered with stucco. Interior walls in the records storage area consist both of plaster and plasterboard: the newer walls are those of plasterboard. There are two windows, measuring approximately  $4 \times 6$  feet (w × h), located on the southeast wall of the records storage area. Both windows are equipped with venetian blinds.

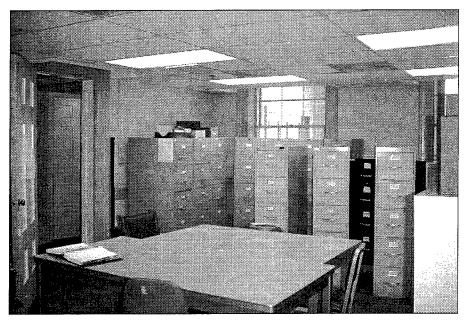
Figure 44. Metal file cabinets in the Morrison Row storage location contain state site files and project notes, all stored in acidic folders.

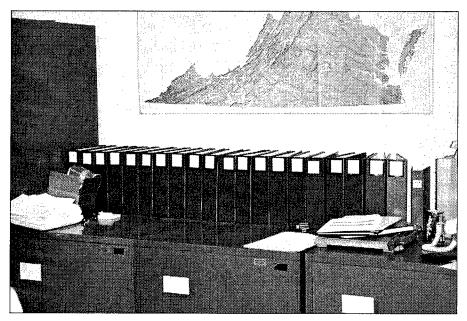
Figure 46. Metal-ring plastic binders in the aluminum building contain county site files.

records generated by a VDHR survey project. All are housed in vinyl three-ring binders measuring  $12 \times 13 \times 3.5$  inches (w × h × d) (Figure 46). These binders are stored on top of several standard-size, enameled-metal cases located against the north wall of the records storage and artifact processing room. The binder labels are contained in metal label holders glued to the spines of the binders. Label information for the county site files is typed, and includes county name. There may be several counties represented within a single binder. County site-file binders are divided by acidic, yellow dividers with plastic label tabs. Divider label information consists of county name.

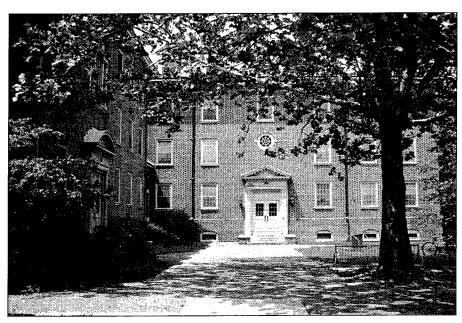
Figure 47. The Bryan Dormitory complex: the laboratory and storage areas of WMCAR.

are housed in the basement of a four-and-onehalf-story dormitory building on the college's campus (Figure 47). The basement repository includes six major areas that encompass approximately 10,000 ft<sup>2</sup>, three of which contain collections or records pertinent to the NAVHOS Portsmouth. There is a separate field equipment storage room, a drafting and report publication area, an archives-storage area, an artifact collections storage area, a photograph processing and large-scale-map storage area, and a laboratory and collections-processing area. Of interest to the St. Louis District team was the archives-storage area (Room 51, ~200 ft<sup>2</sup> [Collections Storage Area 1]), the photograph processing and oversized-map storage area (Room 50, ~100 ft<sup>2</sup> [Collections Storage Area 2]), and the collections storage area (Room 54, ~600 ft<sup>2</sup> [Collections Storage Area 3]).

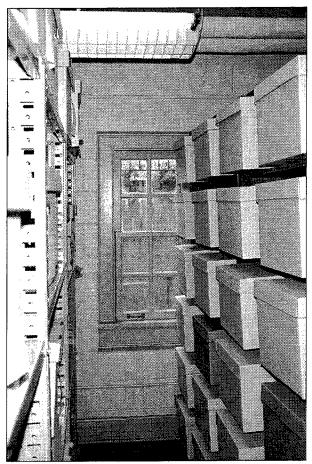
Figure 48. The proximity of collections to exterior basement windows poses a security risk at WMCAR.
